**LEAPING WELL RESERVOIR
MA 00586**

**PHASE I INSPECTION REPORT
NATIONAL DAM INSPECTION PROGRAM**

JUNE 1981

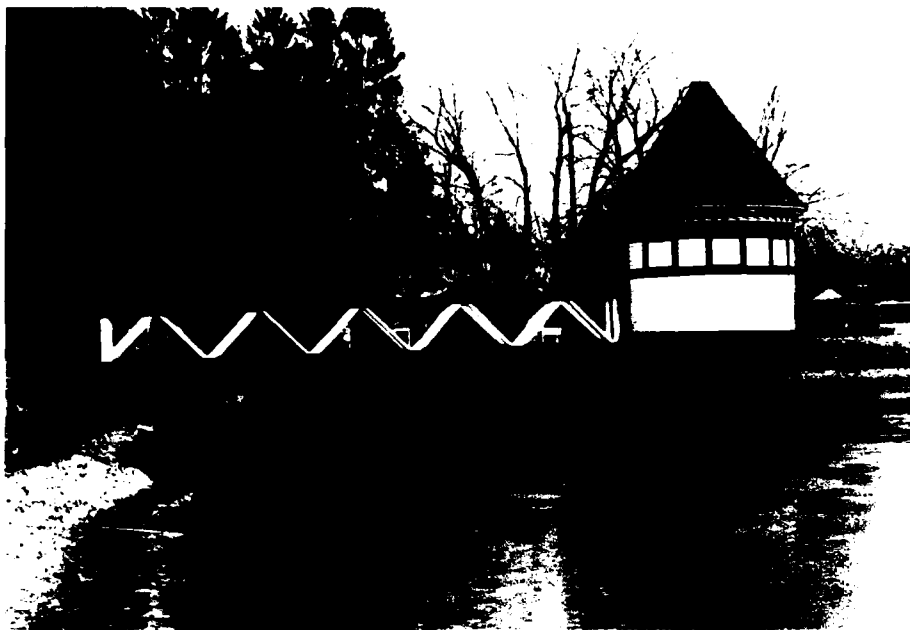
joints. Brick masonry up to 10 square feet has unravelled in the foundation of the structure (see Photos No's. 1, 2 and 3). There is evidence of past repairs to the brick masonry. According to a representative of the South Hadley Water Department, the four gates within this structure have not been operable for 20 years. Seepage is flowing through the brick masonry into the wet well from the surrounding reservoir. The wood framed roof of this structure is in fair condition.

The timber footbridge which spans the waterway between the spillway crest and the gatehouse is in poor condition (see Photo No. 1). This structure is severely distorted and is prone to excessive deflection and vibrations.

PHOTO NO. 1
VIEW OF GATE HOUSE AND FOOTBRIDGE -
NOTE DETERIORATION OF BRICK FOUNDATION

It is recommended that the Owner retain a qualified Registered Professional Engineer to prepare plans for restoring the brick foundation of the gatehouse, strengthening or replacing the footbridge, providing upstream control on the 12-inch outlet, removing trees and stumps, and designing slope protection for both upstream and downstream faces of the north and east embankments. A qualified Registered Professional Engineer should also be retained to perform a detailed hydrologic/hydraulic investigation to assess further the potential of overtopping the dam and the need for the means to increase project discharge capacity. In addition, the Owner should repair the deficiencies listed above, as described in Section 7.3. It is also recommended that the Owner establish a plan for surveillance of the dam during and after periods of heavy rainfall, a plan for notifying downstream residents in the event of an emergency at the dam, and a program of annual technical inspections by a qualified Registered Professional Engineer.

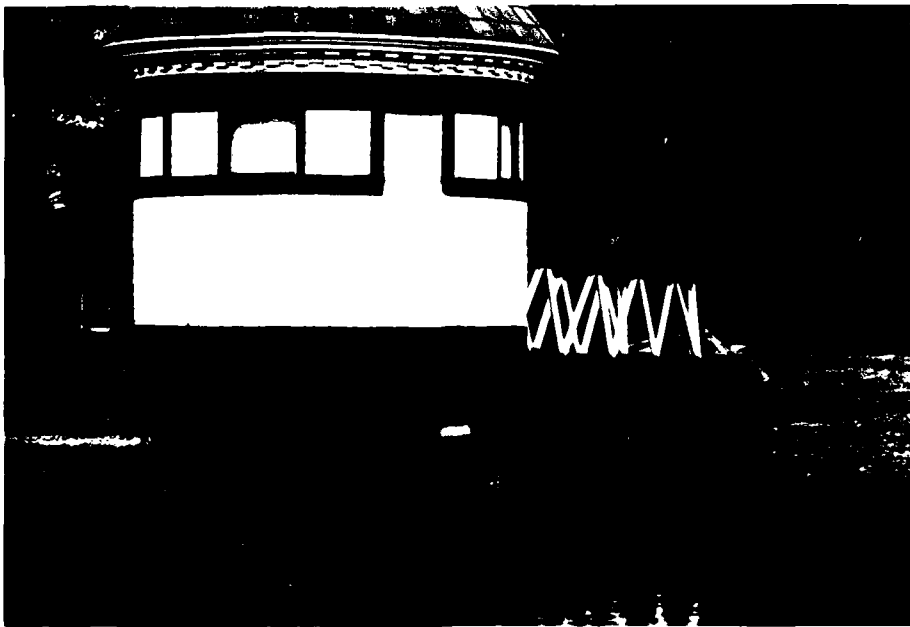
Along the downstream side of the crest of the north embankment is a chain-link fence (see Photo No. 2). There is no significant grass or brush growth along the downstream slope. Near the toe were found a row of stumps and fallen trees. Along the crest of the dam are healthy spruce trees, approximately 6 to 8 inches in diameter. Generally, the dam is heavily rooted with stumps and the existing trees (see Photo No. 11).

PHOTO NO. 2
VIEW OF REAR OF GATE HOUSE -
NOTE OPENING IN BRICK FOUNDATION

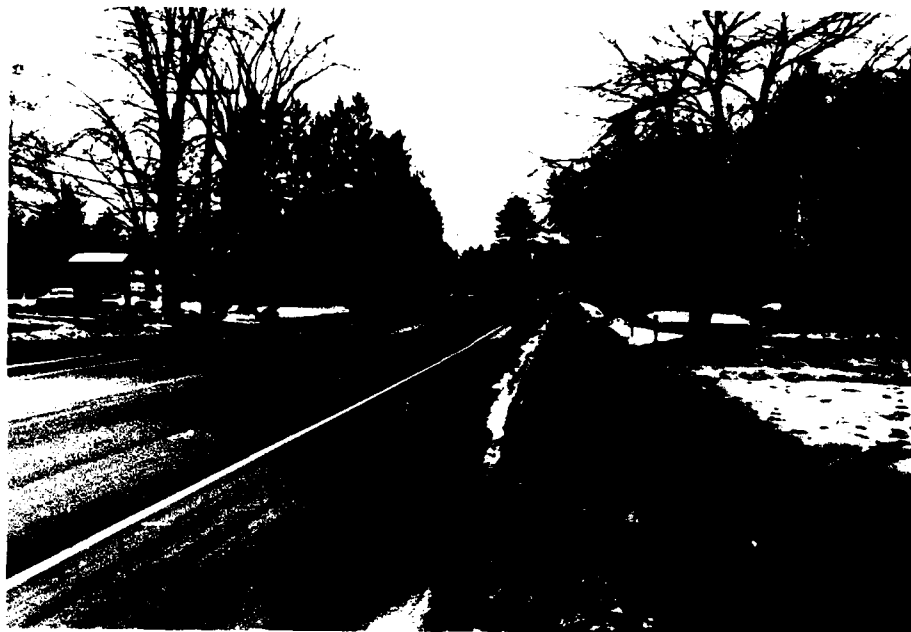
PHOTO NO. 5
VIEW FROM LOW POINT IN ROADWAY
RIGHT OF DAM LOOKING TOWARDS DAM

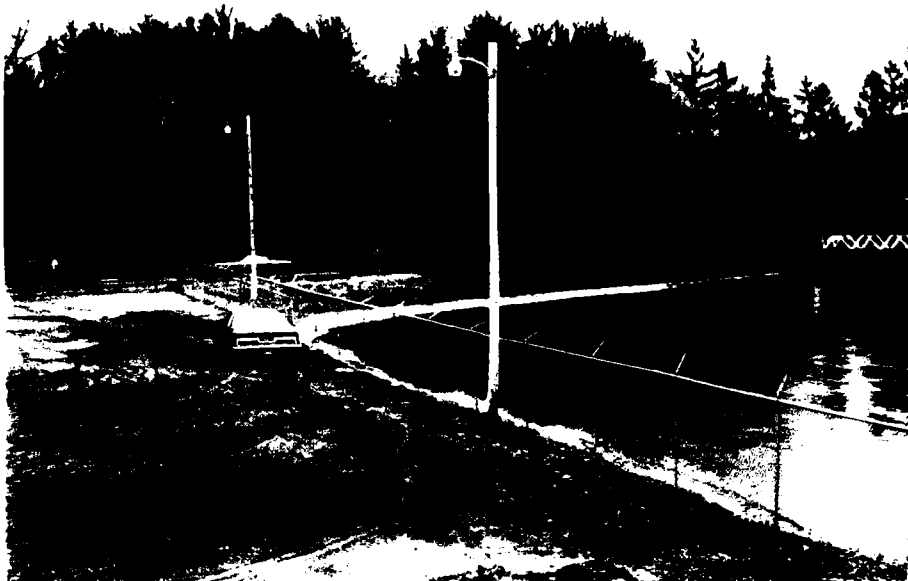
PHOTO NO. 9
VIEW OF WEST RESERVOIR RIM
